163x +5V Rail

The +5V rail in a 1630 series analyser can cause the microprocessor to “reset” if the rail drops to 4.93V. This note lists the known common causes and cures for a poor quality 5V rail.

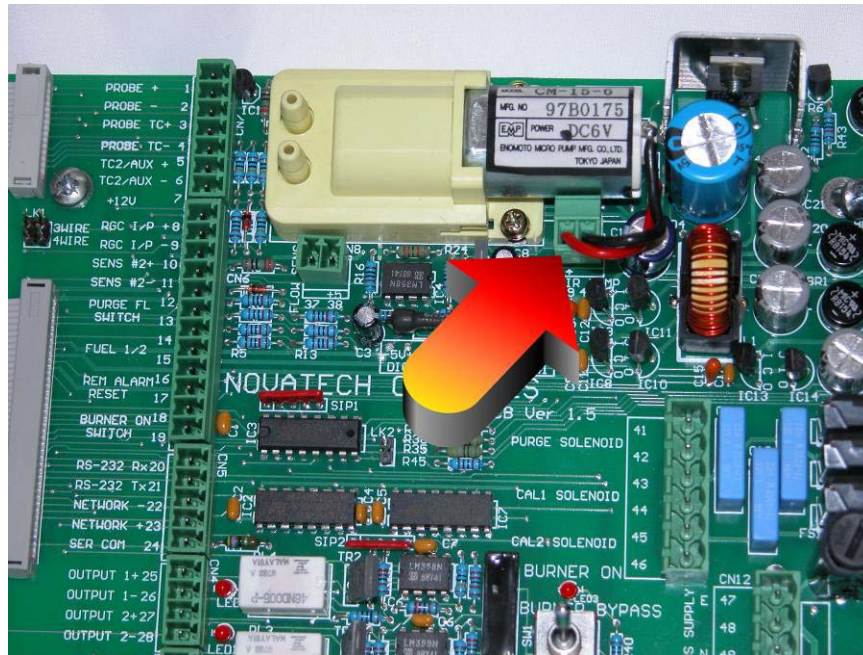
- 1) The CM-15 reference air pump is worn and is drawing a higher than normal current from the 5V rail. This normally results in the analyser constantly resetting itself when the pump is turned on at the end of the start-up sequence. If this stops when the pump cable is unplugged then the pump requires replacement.

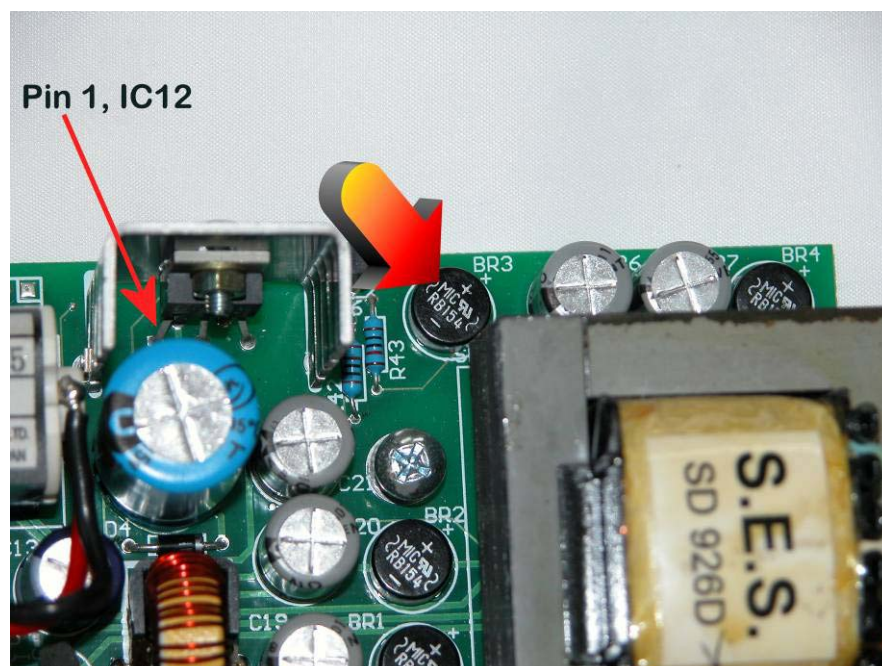
- 2) The bridge rectifier, BR3, has an open circuit diode reducing the available power from the 5V rail. This can be confirmed measuring the pre-regulated DC voltage on pin 1 of IC12, this should be between 14 & 18VDC, or by using a CRO. Replace BR3 and make sure the component is installed so there is at least 3mm between the component and the circuit board. This helps the component to dissipate heat.

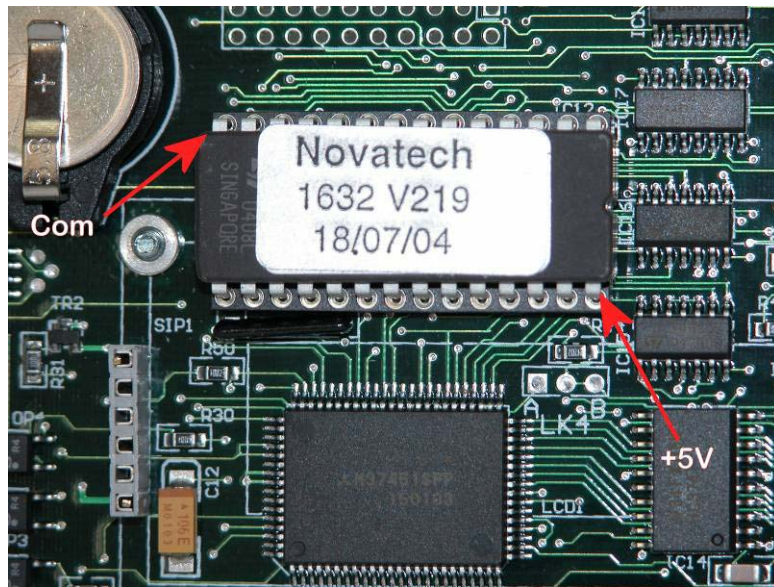
- 3) On analysers with version 1.6 or earlier 1630-2 boards, the 40-way ribbon cable is worn or damaged. Measure the 5V rail on the 1630-2 PSU board and then on the 1630-1 board. If the value measured on the 1630-1 board is less than the value measured on the 1630-2 then the ribbon cable is causing excessive voltage drop.

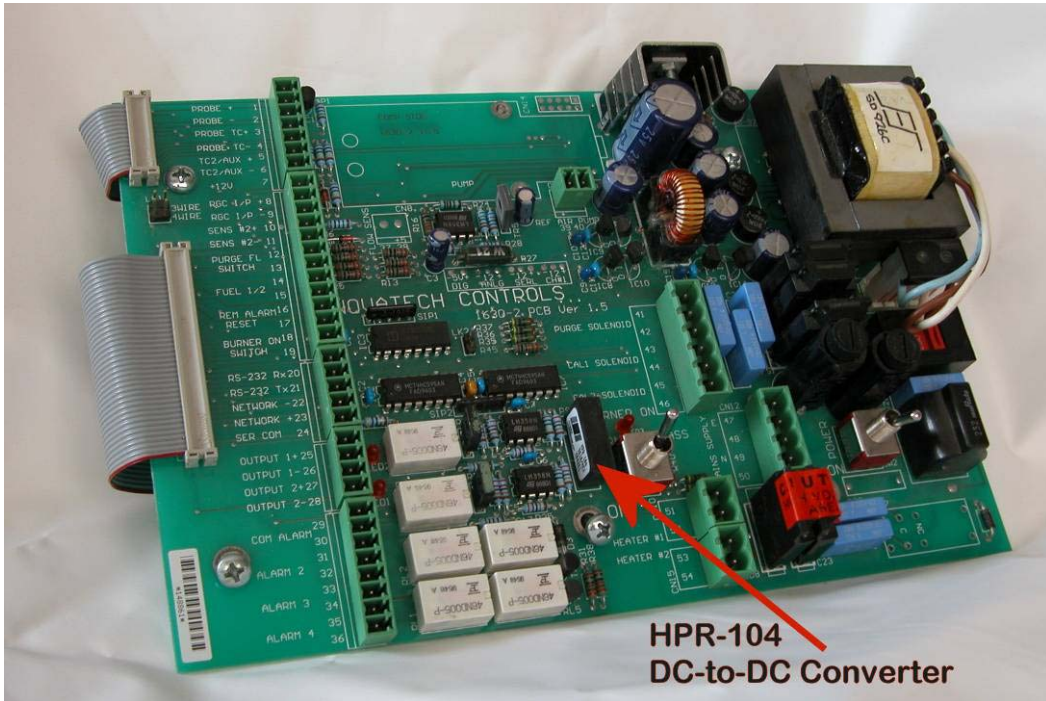
- 4) The DC-to-DC converter, PS1, that powers the output 4-20mA channel 2, can be damaged if a power supply is connected in an attempt to loop power the output circuit. The isolated 4-20mA outputs are active outputs on the 1630 series of analysers. When the DC-to-DC converter is damaged due to loop powering it will overload the +5V rail causing the component to rise in temperature.

Replace the DC-to-DC converter, PS1, with an HPR-104 (5V to +/-12V).
